Planning for the Recovery of the Transportation System after a Major Earthquake

Richard A James, B. Sc., MICE, C Eng, P Eng, PTOE

Abstract

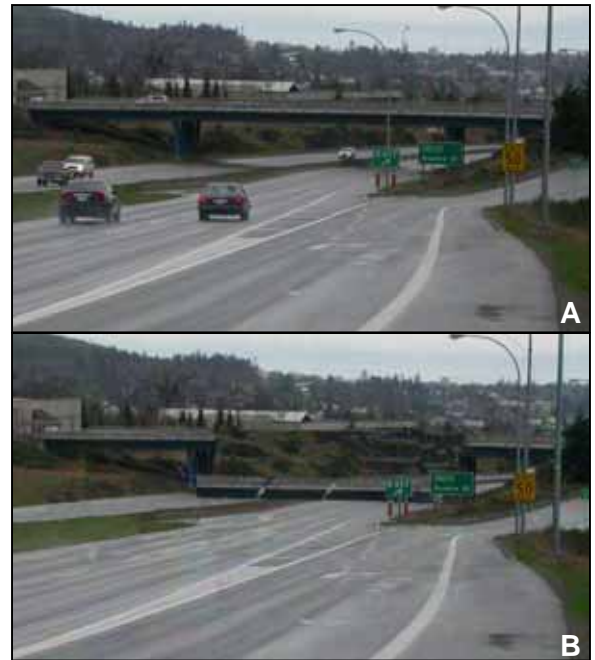
Figure 1 Potential Bridge Failure

1. Bridges: while collapse of structures designed post 1983 is not expected in a design event, it is nevertheless a possibility for older structures, or in a greater than design event. Bridges may be freeway interchange structures (as in Figure 1) or bridges carrying a facility over a river or marine inlet. Freeway interchange structures are generally easier to deal with, while water crossings, especially if the feature is deeply incised, may be more problematic.

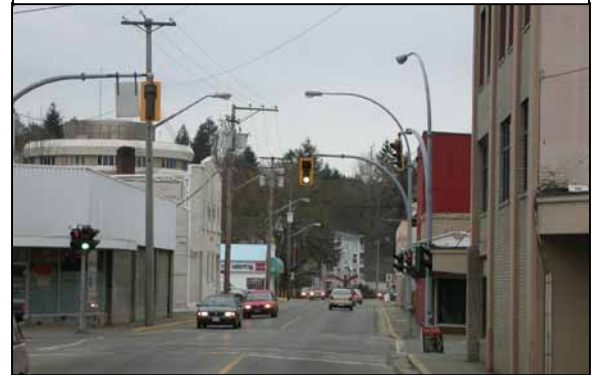
Figure 2 Potential Building Failure

2. Building Failures: in areas with buildings abutting the sidewalk, building failures will cause at least temporary disruption. In more densely developed areas (downtown Victoria, Nanaimo) the extent of the debris field will potentially be quite large with many unreinforced brick or stone structures.

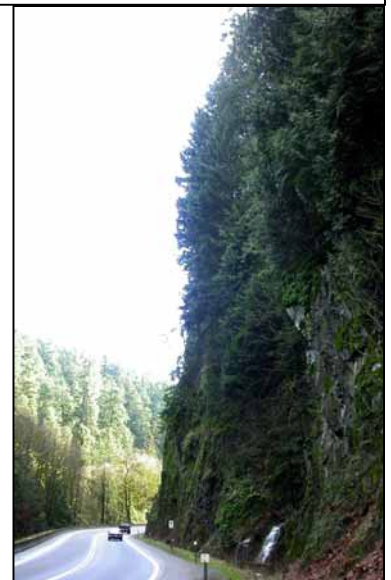
Figure 3
Potential Rockfall Hazard

3. Rock falls: many roads, especially in rural areas on Vancouver Island, pass through rugged terrain where rock cuts are frequent. The hazard area may extend hundreds of meters along the facility, and many tens of meters up the slope (potentially hundreds of meters). The hazard may include overburden and vegetation as well as rock from failure of the cliff face itself. The width of the road has a significant impact on the disruption caused by a rock fall. On narrow two lane facilities a major fall may block the road for a significant time period. On wider facilities (4 lanes, full shoulders and wide median) the same event may only require a detour to the opposing lanes for the clearance period.

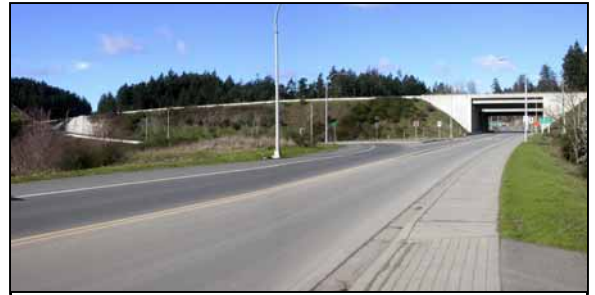
Figure 4 Recently Constructed Fill Slope

4. Fill Slopes: post 1983 fill slopes (Figure 4) are generally expected to perform well. However earlier fills may have been constructed by end tipping, may contain unstable material and may already be subject to failure under "normal" conditions. Fills constructed on seismically poor ground without adequate precautions are particularly liable to failure by slippage and/or liquefaction of the underlying material (Figure 5).

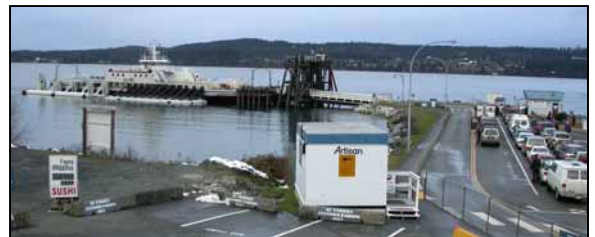
Figure 6 Ferry Terminal Marine Structures

5. Ferry Terminal Marine Structures: both smaller inter-island terminals and larger mainland service terminals are potentially subject to seismic damage. The Tsawwassen terminal may be particularly susceptible to damage from soil liquefaction both for the terminal structures and for the approach highway across the Fraser River delta. Smaller terminals, whilst potentially vulnerable, may be easier to repair, or, reasonable alternatives may exist by using (for example) barge services on an interim basis.

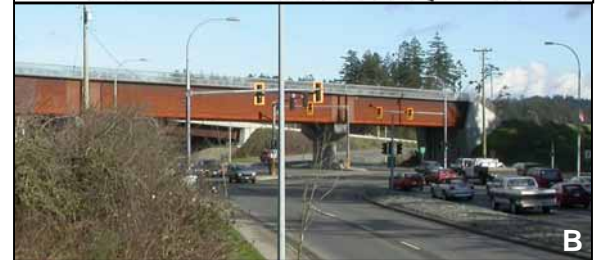
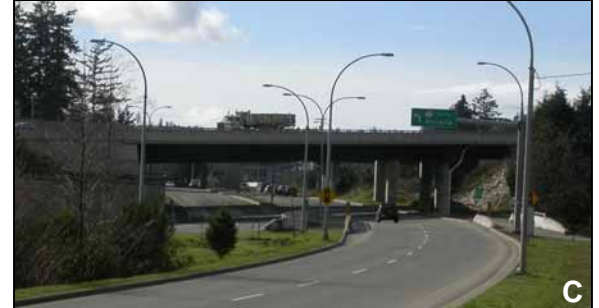
Figure 10 Risk Site 1

In this case study a freeway interchange (half diamond, Figure 10, Panel "A") connects two parallel highways passing within approximately 2-300m of each other with a single-track railway bridge (Panel "B") between them (major bridges in red).

Highway 1 (TCH, Panel "C") passes through the area on the overpass; the "Old Island Highway" passes parallel to Highway 1 on the south side. The major traffic flow is along the TCH and to/from the west leg of the Old Island Highway. The east leg of the Old Island Highway has connectivity but is a low standard two-lane facility. There are a total of eight structures in the complex. To the immediate south is the upper end of a tidal inlet with precipitous rock faces down to the water. To the north is a major regional park (natural area) with "difficult" topography. There are no reasonable routes around this area.

The interchange is a critical linkage between the expanding "West Shore" area and the older parts of the community including the Downtown area, both major hospitals (one in the blue area, Panel "D") and ferry terminals.

We can deal with the railway bridge, as it is a short span (<10m) structure by planning for removal of debris if it fails. We can plan for temporary use of the creek bridge with a "Bailey/Acrow" structure or temporary replacement with a culvert and rock fill.

Diamond type interchanges are simple to deal with as the structure can be replaced by use of the ramps with median crossings to replace the structure, effectively creating a sausage shaped "roundabout" (Panel C).

However, we should also look more closely at the immediate area of the primary structures. This reveals two potential detours (green) that are achievable with minor construction. To the immediate right (east) of the site there is a short stub roadway ending approximately 50m from the highway and essentially level with it. This can easily be connected to the highway. This road passes under the railway, but this structure is <10m in span and can easily be removed if it fails. To the left (west) is an adjacent road with an elevation 2-3m below the highway. This could be connected with some blasting and fill. If the minor structure on this road fails, the creek could be curvetted or bridged with a temporary structure.

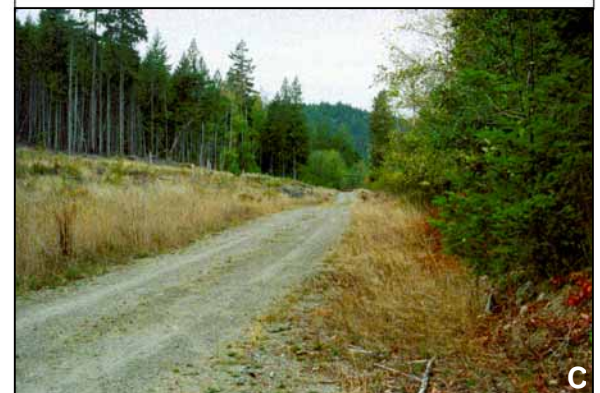
Figure 16 Case 4 Rural Area

Figure 16 Panel "A" identifies typical features including:

- Main road - red
- Existing local roads - blue
- Existing logging roads - green
- Rockfall hazard areas - magenta

Road standards on the logging road system varied from quite overgrown and eroded to straight, serviceable segments (Panel "C") and in some cases paved roads that were constructed for failed sub-division projects.
